OPERATION AND INSTALLATION MANUAL

EN-1366

HYDRAULICALLY CONTROLLED
VARIABLE PITCH PROPELLERS
(CONSTANT SPEED)

Issue 3: May 19, 2010
Revision: December 4, 2019

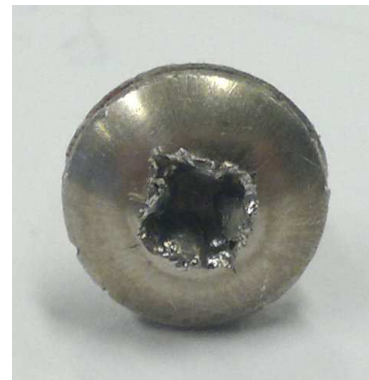
Figure 5-3-1

USING OF SCREWS WITH DAMAGED CROSS SLOT FOR MOUNTING OF THE SPINNER DOME IS STRICTLY FORBIDDEN. USING OF SUCH SCREWS CAN CAUSE IMPROPER TIGHTENING OF THE SPINNER DOME LEADING TO THE CRACKS. SCREW WITH DAMAGED CROSS SLOT MUST BE ALWAYS REPLACED BY NEW. REFER TO FIGURE 5-3-1 FOR EXAMPLE OF DAMAGE OF THE CROSS SLOT.
